Water Supply and Treatment

# SOURCE WATER

JUNE 2026 UPDATE

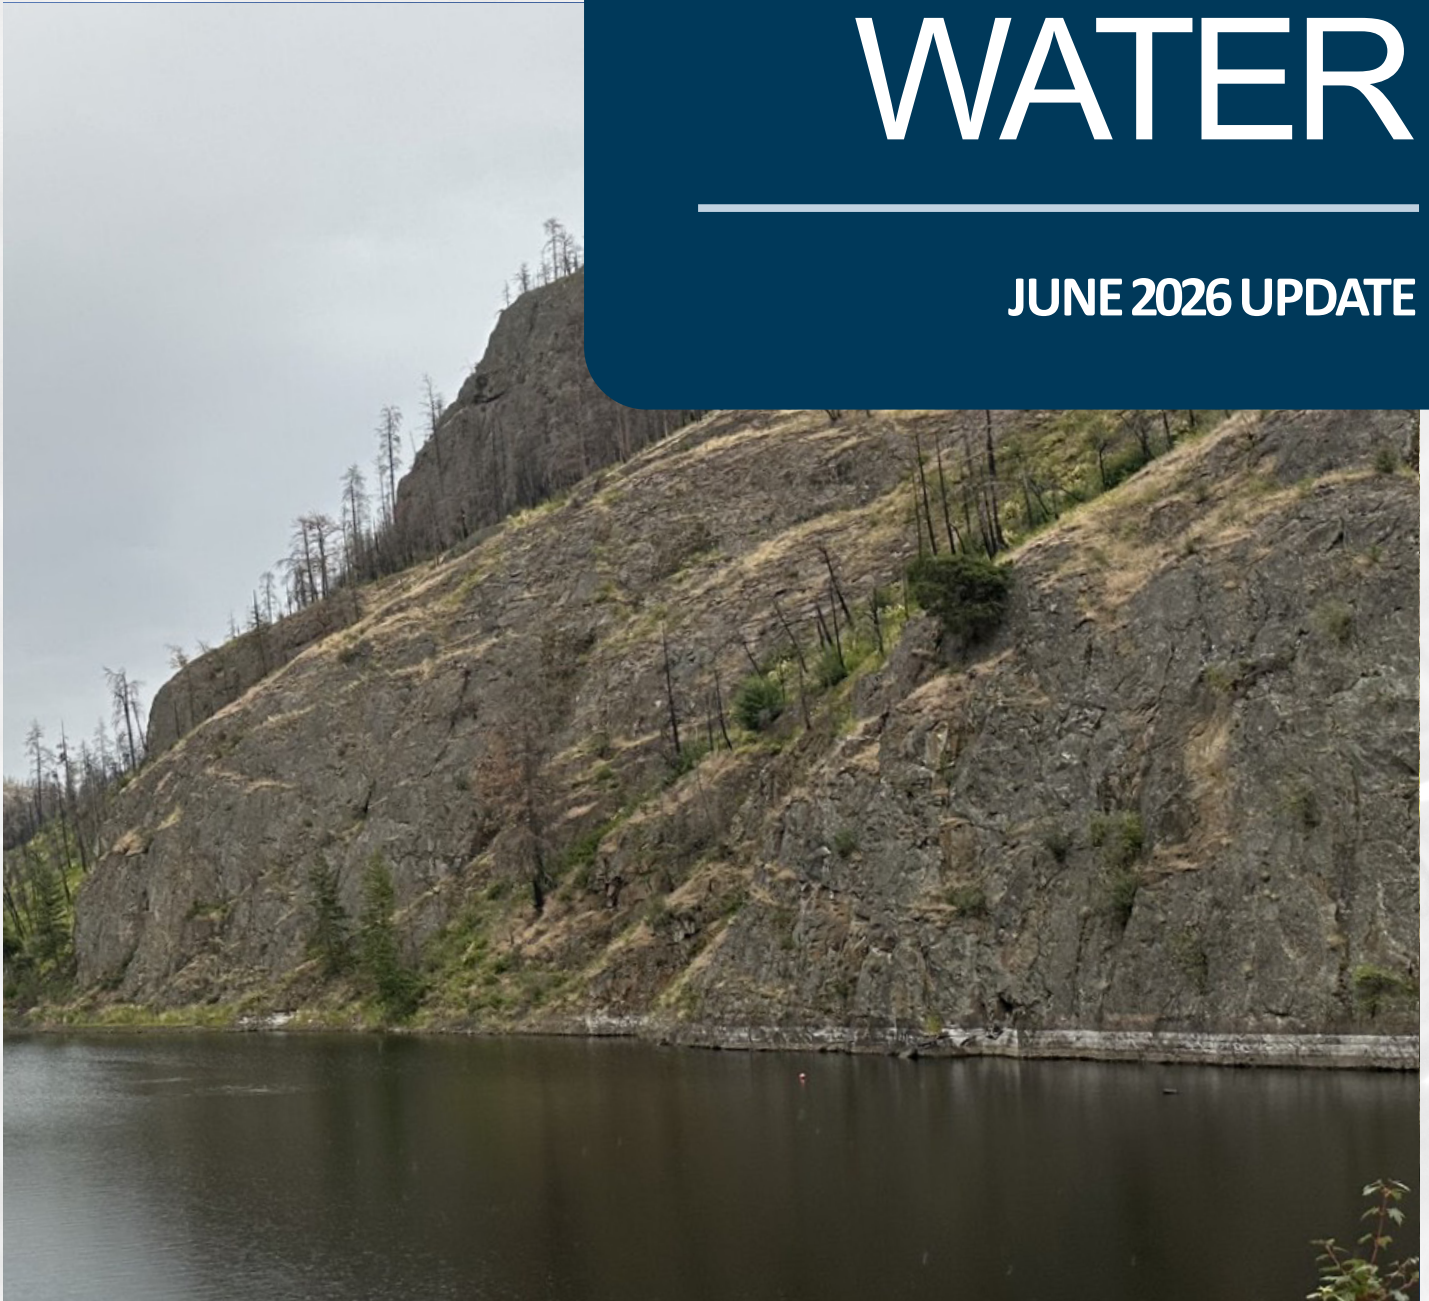
*Photo: Rose Valley Reservoir on June 30, 2026.*
